The Impact of Environmental Changes and the Damage to the Structure of Beach Buildings in the Southeast Jazirah of Saparua Island, Central Maluku District

Rudi Serang, Delvia Rimesye Apalem

Ambon State Polytechnic, Indonesia

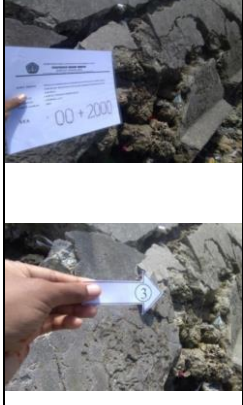
3

The building functions only 25% to 50% but does not endanger the environment.	150	D (Less preferred)
4

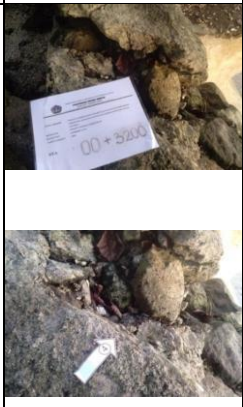
The building is still functioning 50% until with 75%.	100	D (Less preferred)

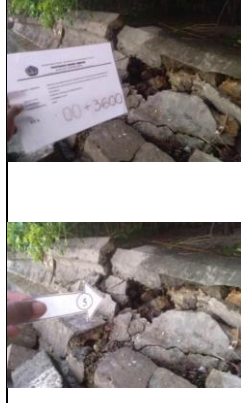
5

Buildings only function 25% to 50% and are harmful to the environment.	200	C (Preferred)
---	--	--	-----	---------------
