Analysis Damage to the Inpres Elementary School Building Village Asilulu Central Maluku Regency

Civil Engineering Department, Ambon State Polytechnic, Indonesia

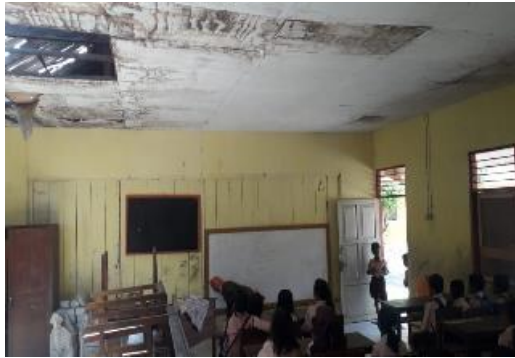
Fig.1 Classroom _

2013. Impact _ the damage is very annoying comfort and safety from the students during learn , so objective For educate and increase quality education Not yet reached . However until moment This Still there is facilities and infrastructure broken education _ but Still used for the learning process teach . circumstances This influence quality and quality students' education . Room roofed class _ already leaked, however Still used as place for the learning process teach . Comfort The same very No felt by students. If happen Rain hence the learning process teach discontinued because the roof of the school leaked so it rained enter to room class , as well influential to another part of building building the . Although building building the Already broken , still used for the learning process teach as seen in figure 1. The students have to sit side by side For avoid rain and hot water incoming sun _ to room class .

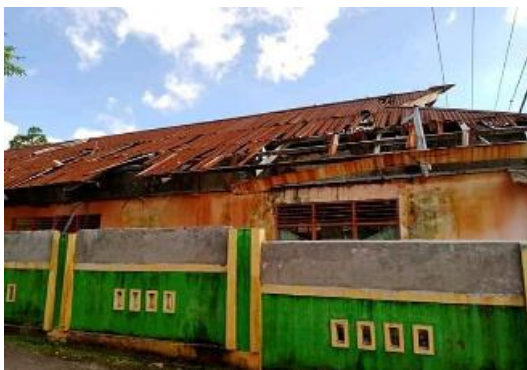
Fig.2 Roof Damage

In pictures 2 and 3 the roof covering is done experience effect damage _ For damage framework easel and ceiling.

damage done _ building roof , frame truss , ceiling, walls , and columns resulting in a zinc roof can become rusty . Besides it's on the zinc roof No coated with anti-rust paint so damage the more big that is happen leaks , and visible the holes in the roof . Perforated roof , if happen Rain so will seep and hit the frame easel and ceiling. Consequence damage to the zinc roof factor The wind is also very influential in the area that , when in the west season often happen strong winds , which resulted level damage the more big ,

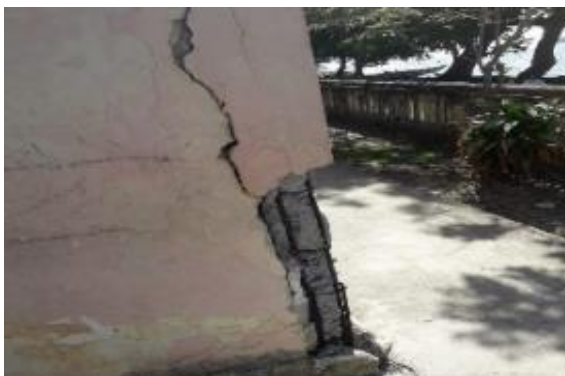
Fig.4 Damage column

In pictures 4 and 5, beauty and cleanliness school No appear Again consequence damage . Wall school experience cracks and paint already chipped . column experienced cracked as well as has appear reinforcement , consequently strength from column can reduced . Besides That maintenance something building often ignored by the government area specifically Central Maluku Regency . Damage this also happens in a few areas in Indonesia such as case consequence damage building school behind _ Board according to *Mahfud* consequence No he did maintenance in a manner periodically so that resulting in fatalities . Management review maintenance and maintenance _ researched by *Irika Widiasanti* and *R. Eka Murti Nugraha* say that maintenance building is very important and expected can done in a manner periodically so the funds will be used more efficient.

the reinforcement column see already experience corrosion like seen in picture 5. Use sand the pregnant sea sulfate and chloride salt , can influential against damage concrete ie reinforcement iron concrete to be rust , part dash already cut off Potential damage to concrete ie happened cracks and breaks , because salty sand _ will reduce adhesive with cement, as seen in picture 6.

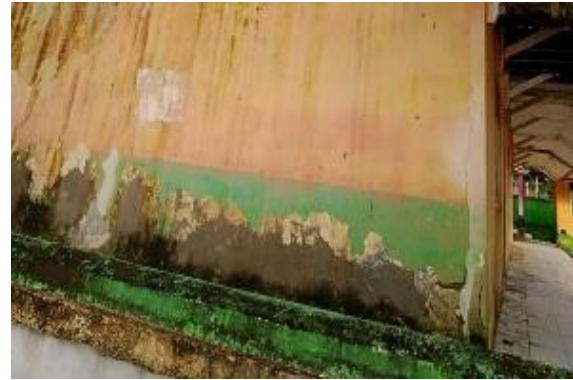
Fig.5 Damage wall

Paint on walls the building has peeling and discolored faded . Doors and windows already _ broken . Damage covering the roof, damage wall on each room experienced class _ cracks , reinforcement in columns that have appear consequence corrosion . Besides That in development will impact on the budget government , if building school will rehabilitated or built new .
